Thermal Patterns Due to Moisture Accumulation within Exterior Walls

*Antonio Colantonio, Garry Desroches
Public Works And Government Services Canada*

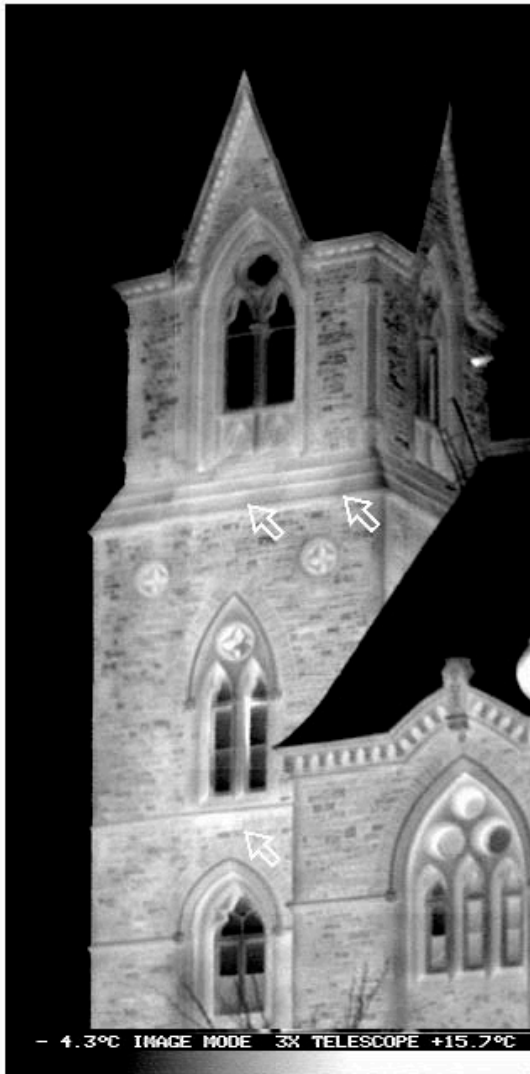
Figure 1. Neutral Building Pressure (0 Pa), $T_o = -8^{\circ}\text{C}$, No precipitation or snowfall for at least 7 days prior to inspection.

parapets are examples of such drainage features. Sloped relief details in stone masonry walls are another example of such conditions. (Refer to **Figure 1**)

Sloped areas on stone and masonry walls are areas that attract melt water throughout the winter months. Often these areas are also characterized by staining and dirt build up created by the surface water accumulation. In many of the buildings investigated there was a correlation between the dirt build up on stones and moisture accumulation within the wall and the specific stones.

Arrows point to suspected moisture accumulation within the limestone cladding due to rain and melt water throughout winter months.

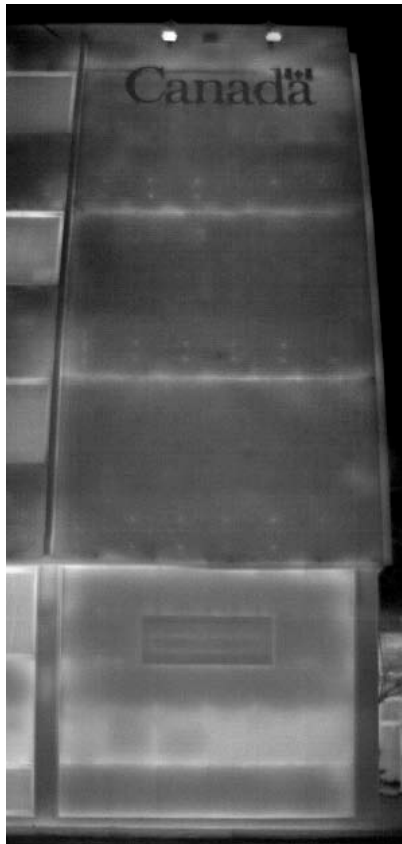
The two images below (**Figures 2 & 3**) demonstrate the amount of moisture accumulation that can occur within masonry cladding as a result of stack effect brought on by low winter exterior ambient temperatures. Both images taken during negative building pressures are void of air exfiltration patterns but **Figure 3**, taken at a lower ambient temperature (-11°C), displays a greater amount of moisture accumulation within the masonry cladding at the top of the building than **Figure 2** taken at temperatures approximately 10°C higher.

The only other variable in this image is significantly increased negative pressure in the higher temperature situation that could have resulted in slightly modifying existing moisture patterns. The increased negative pressure, combined with the time prior to inspections that this condition existed, may have reduced the amount of moisture within the wall cladding. In addition, due to reduced exterior ambient temperatures, stack effect would have been reduced for the period prior to capture of image in **Figure 2**, thus reducing the amount of moisture, especially at the top of the building envelope.

Figure 2. Negative Building Pressure (-140 Pa), $T_o = 0^{\circ}\text{C}$ **Figure 3.** Negative Building Pressure (-8 Pa), $T_o = -11^{\circ}\text{C}$

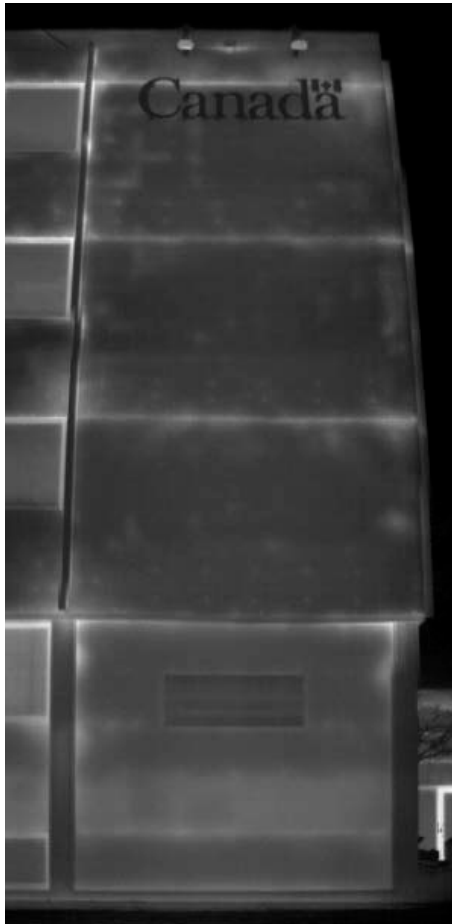
Figure 4. Positive Building Pressure (+40 Pa), $T_o = 0^\circ\text{C}$

The two images in **Figures 4 & 5** above demonstrate the amount of moisture accumulation that can occur within masonry cladding as a result of stack effect brought on by reduced exterior ambient temperatures. Both images, taken during positive building pressures, display thermal patterns created by air exfiltration patterns in addition to previously accumulated moisture patterns due to stack pressures. These air leakage patterns overpower the moisture induced thermal patterns in both exterior ambient temperature conditions.

The image taken at the lower ambient temperature illustrates a greater amount of moisture accumulation within the masonry cladding than the image taken at temperatures approximately 10°C higher. This is consistent with the thermal patterns produced during the negative building pressure inspections. The only other variable in this image is slightly increased positive pressure in the higher temperature situation that could have resulted in the slight modification of existing moisture patterns.

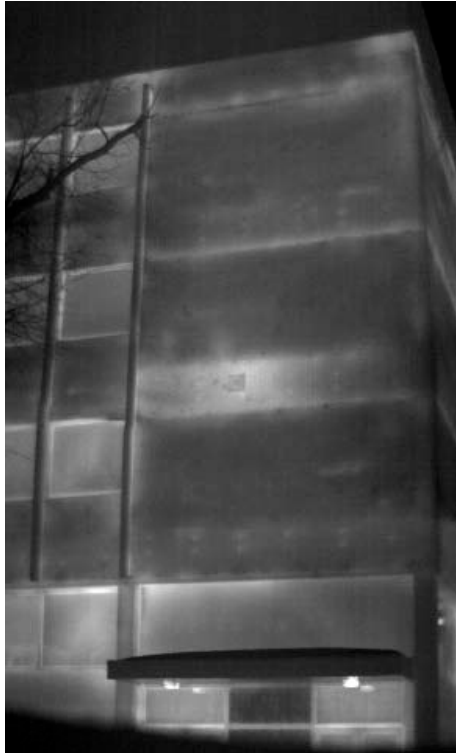
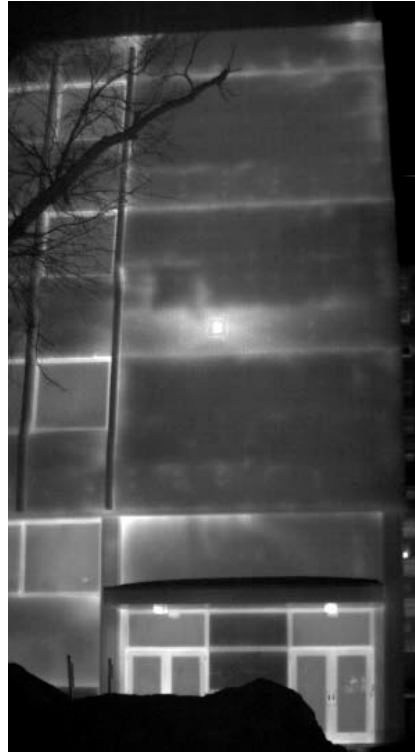
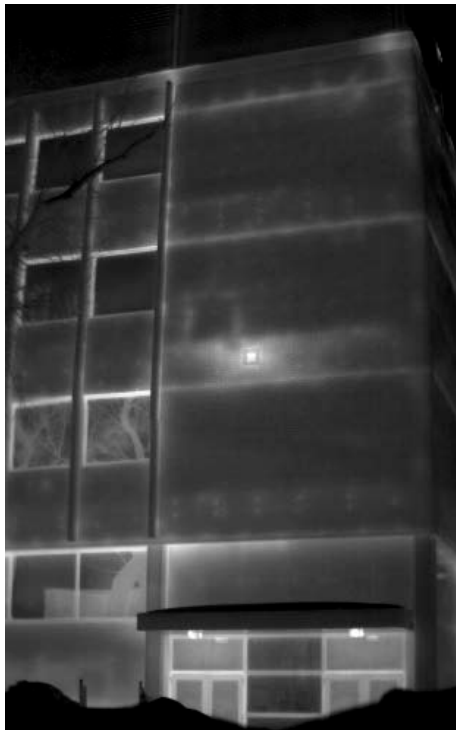
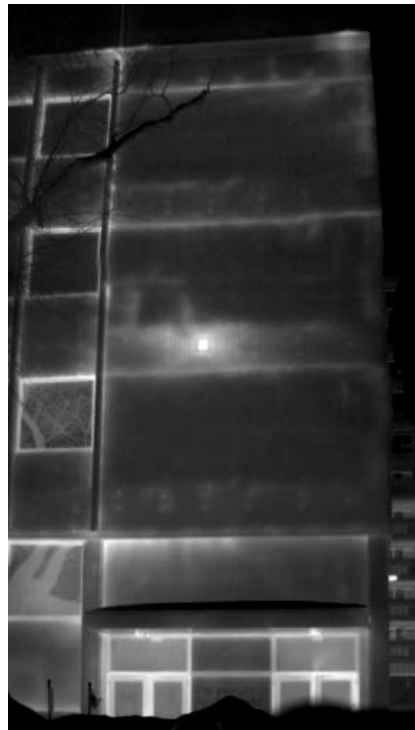
The thermal images seen in **Figures 6 to 9** demonstrate the variances between moisture patterns created by both direct and diffuse air leakage. These images also illustrate the variations during both positive and negative pressure conditions during inspections.

Moisture patterning is most visible during negative building pressure inspections since air leakage patterns do not overpower those created by moisture within the cladding or insulation. If conducting inspections within an hour or so after initializing negative building pressure, then moisture patterning created by normal operating conditions become most visible in the infrared image. Moisture patterning appears to be more apparent in areas where diffuse air leakage occurs through the exterior walls rather than at areas where direct air leakage occurs during these inspections. One possible explanation for this phenomenon is that in diffuse air leakage conditions, moisture has a greater potential to get trapped into porous materials rather than in situations where direct air leakage occurs from the interior to the exterior. What has been generally observed is that moisture accumulation around areas of direct airflow paths occurs at the peripheral areas of the openings and not immediately at their locations. Again heat and air flow from the exfiltrating air generally will not allow for moisture retention at the immediate opening but rather some distance around the openings where there is less air flow to move the moisture further out of the cladding materials. In very cold conditions (-30°C and lower), visual signs of hoar frosting is visible at these problem areas.

Pre-existing moisture patterning does not seem to be affected to any degree during positive pressure inspections other than to make them less apparent due to the much warmer surface temperatures created by the exfiltrating air at openings within the air barrier assembly. Positive building pressure inspections will result in additional moisture deposition within the wall assembly and thus create additional areas of moisture accumulation within the wall area that may not be present during normal operating conditions of the building. Both significant pressure (between 50 to 150 Pa) and considerable duration (greater than 4 hours of positive pressure) are required before additional moisture patterning is visible due to positive building pressure conditions in structures with average to above average leaky air barrier assemblies.

When looking at buildings during cold weather conditions, variations in the thermal signatures created by naturally occurring conditions will take considerable time to be modified and in some conditions, may not be modified at all. In **Figures 6 to 9** the masonry areas around the vent located in the central section of the third floor appears warm even in the negative pressure inspections even through negative pressures were imposed for more than 2 hours prior to each inspection. Exterior ambient temperature seems to have little affect on the dissipation of stored heat and moisture within the masonry around these locations. In these conditions, greater time is required under negative building pressure to eliminate the stored heat from air leakage within the masonry cladding.

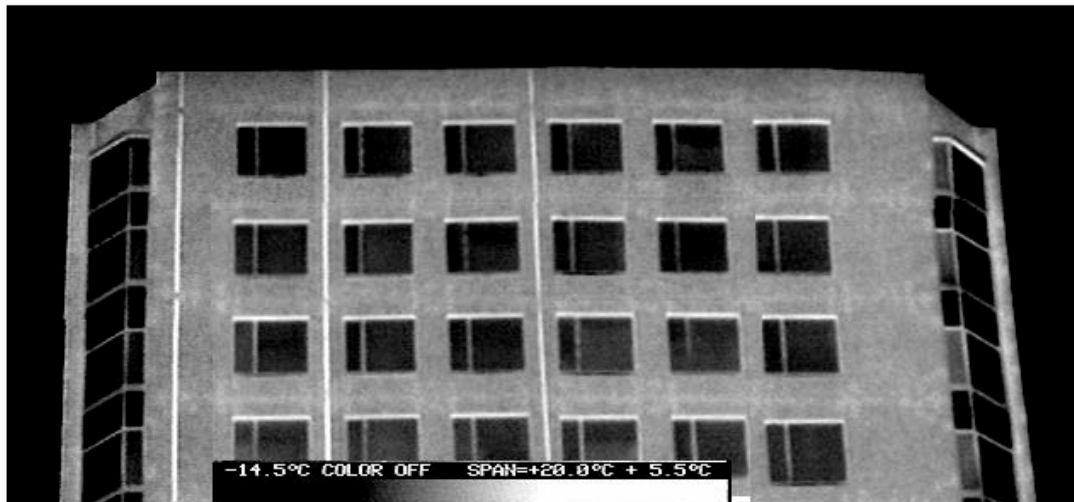
Figure 10. Negative Building Pressure (-60 Pa), $T_o = -7^{\circ}\text{C}$, maintained for a duration of 4 hours prior to inspection.

The composite thermal images in **Figures 10 & 11** were taken on subsequent mornings, but in **Figure 11** positive pressure imagery was produced 24 hours prior to the negative pressure imagery. The arrows at the parapet walls of this 24-storey building identify the moisture accumulation within the brick cladding as a direct result of positive building pressure imposed on the building for test purposes. The moisture patterns were not present prior to the positive building pressure being induced into the building and did not appear until after 4 hours of positive building pressure.

Figure 10 illustrated the thermal imagery from the same area of this building while being subjected to negative building pressure the following evening. Note that the thermal patterns due to air leakage are absent from this image as are the patterns created by the moisture accumulation within the brick cladding at the upper sections of the elevation. The thermal bridging patterns are still evident. This image indicates that moisture accumulation, as with heat build up due to excessive air leakage, given a full 24-hour time period, will dissipate when the driving force of the heat and moisture accumulation within the cladding is not present.

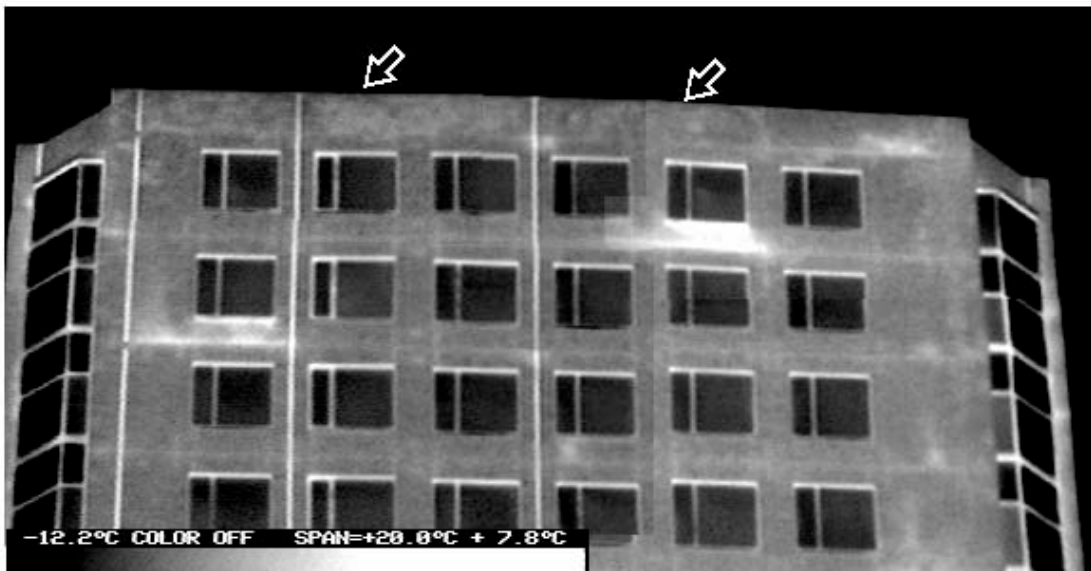
11. Positive Building Pressure (80 Pa), $T_o = -7^{\circ}\text{C}$, maintained for a duration of 5 hours prior to inspection.

As seen in **Figure 11**, leakage areas were random in various sections of the building and were not wide spread, but the sustained abnormal positive building pressure during testing did result in additional moisture migration from the building into the masonry cladding. This is a common occurrence in both solid as well as cavity wall assemblies. In cavity wall assemblies, moisture migration often travels from

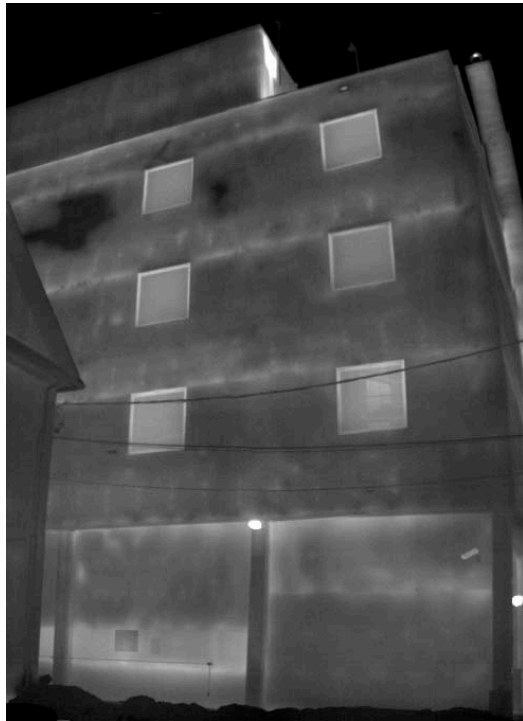
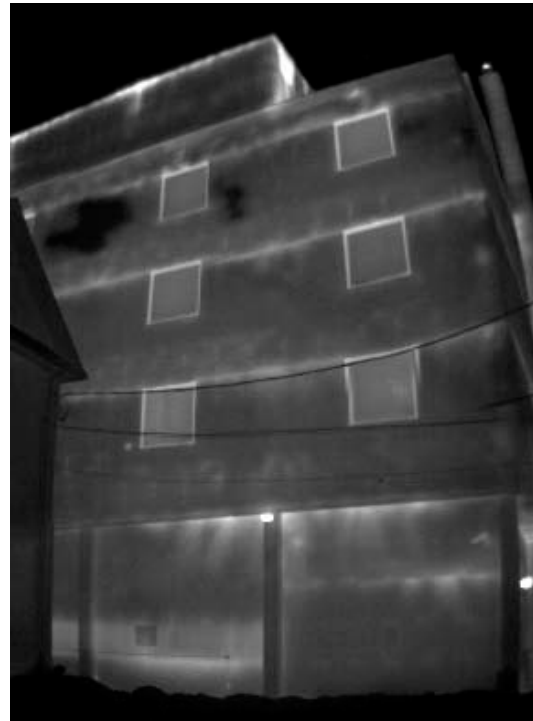
The dark areas on the 4th floor masonry illustrate the thermal pattern generated by the phase change of masonry moisture. It appears reasonably consistent during both the negative and positive inspections of this building during the same evening. Note the cold areas above the window heads on the third and fourth floor windows typical of air leakage into the building during negative building pressure conditions.

Both images taken during same evening, 4-hour time span between the two images.

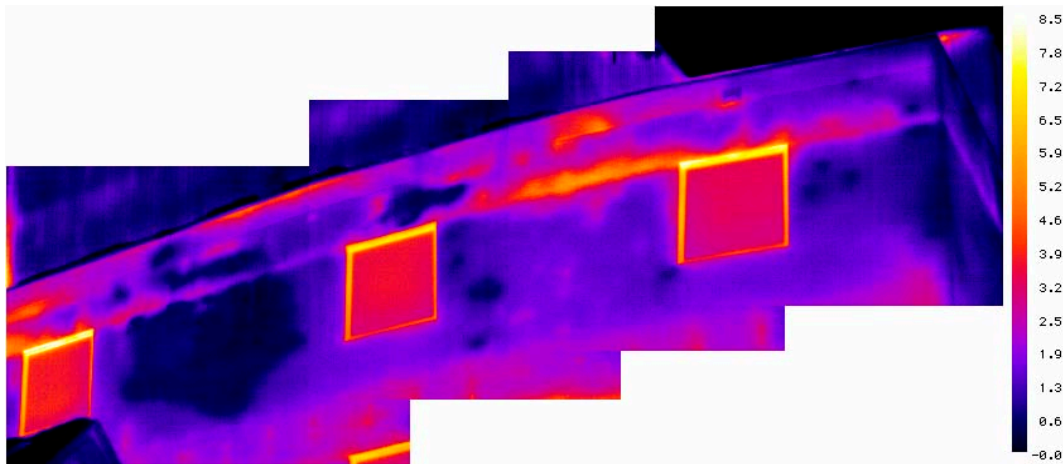
Figure 14. Positive Building Pressure (+3 Pa), $T_o = -1^\circ\text{C}$, Close up thermal image of previous images in **Figures 12 and 13** showing phase change of moisture within masonry. This image was taken a year earlier than previous images but generates the same type of imagery.

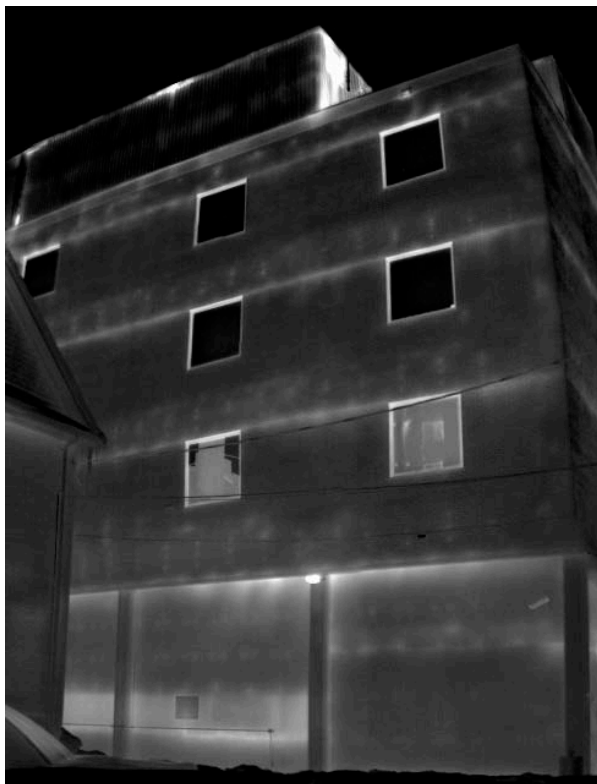
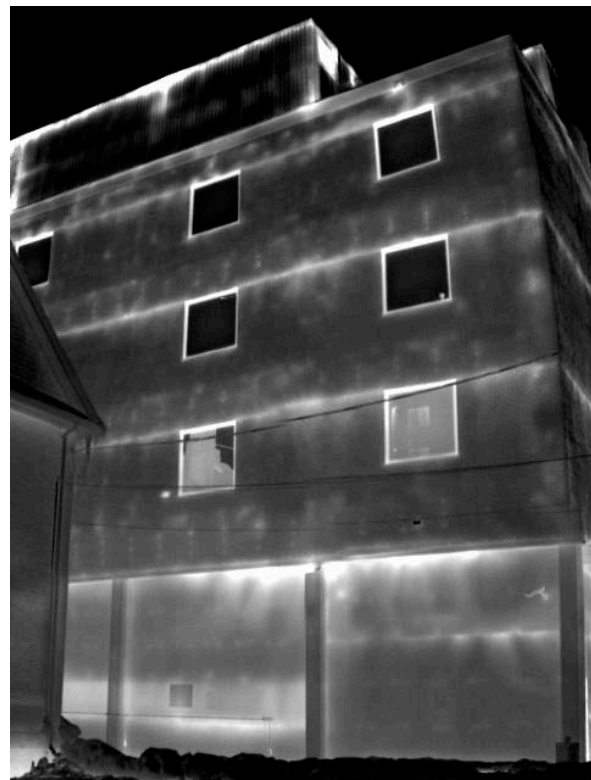
The moisture patterning within the wall due to accumulated moisture over the winter months appears warm around the floor slabs and is present during both the negative inspections as well as the positive pressure inspections. During the positive building inspection, these moisture patterns appear to be overpowered by the thermal patterns created by the air leakage through the walls from the building interior.

Both images were taken during the same evening, 4 hours between the two settings. Due to the lower exterior ambient temperatures, phase change phenomenon is not visible at low outside temperatures. Moisture accumulation is visible during both inspections, but more during positive building pressure inspections than slightly negative pressure inspections.
